# Manhole Inspection Summary

Manhole # S07AA2017MH

**Location** Address: **2800 CROSS COUNTRY BLVD** Cross Street: **WESTERN RUN DR**

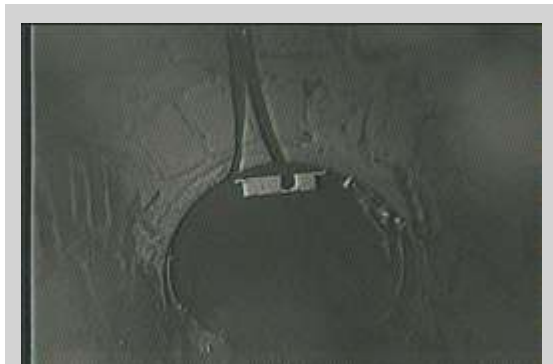
Pipe In @ 4 O'Clock

### 12 in. Circular Gravity Sewer

Rod and Bar (Angled)

Pipe Material: **Unknown** ☐ Pipe Lined

Infiltration: **None** Pipe Seal Cond: **Unknown**
